Report number: R20183

Type of report : Partially survey

Date of survey : 23<sup>rd</sup> December 2020

Make / type : Van de Stadt 44 Satellite

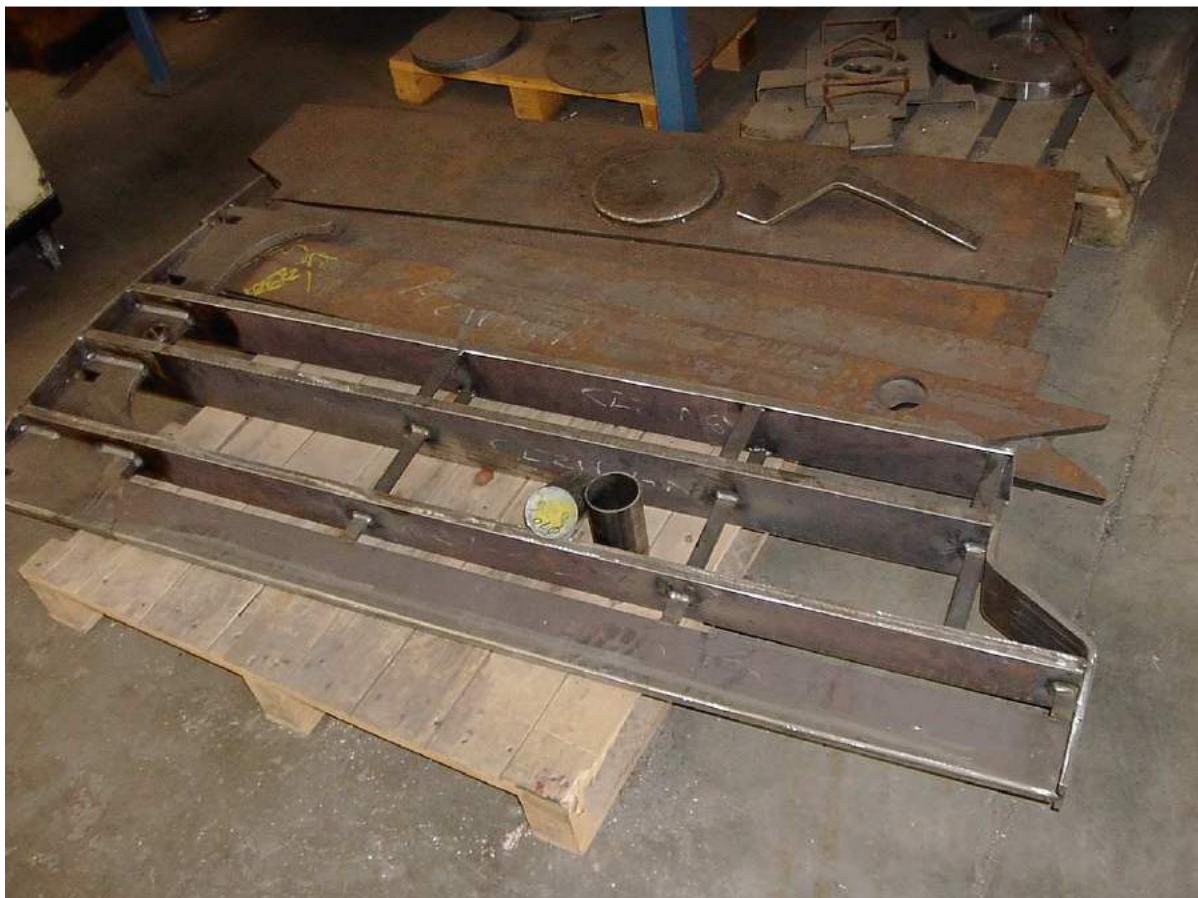
***Steel keel movable part. - left attachment for bulb - temporary studs for welding support.***

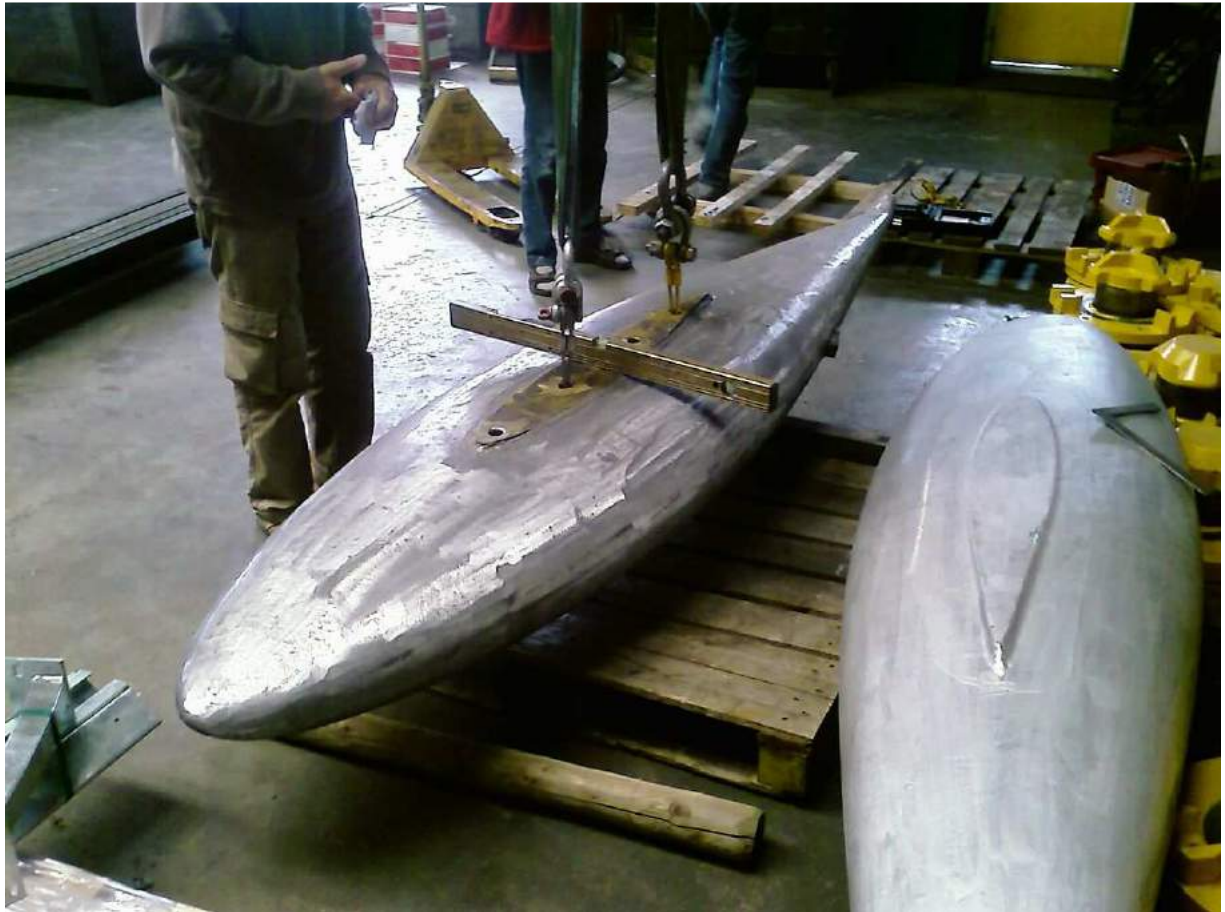
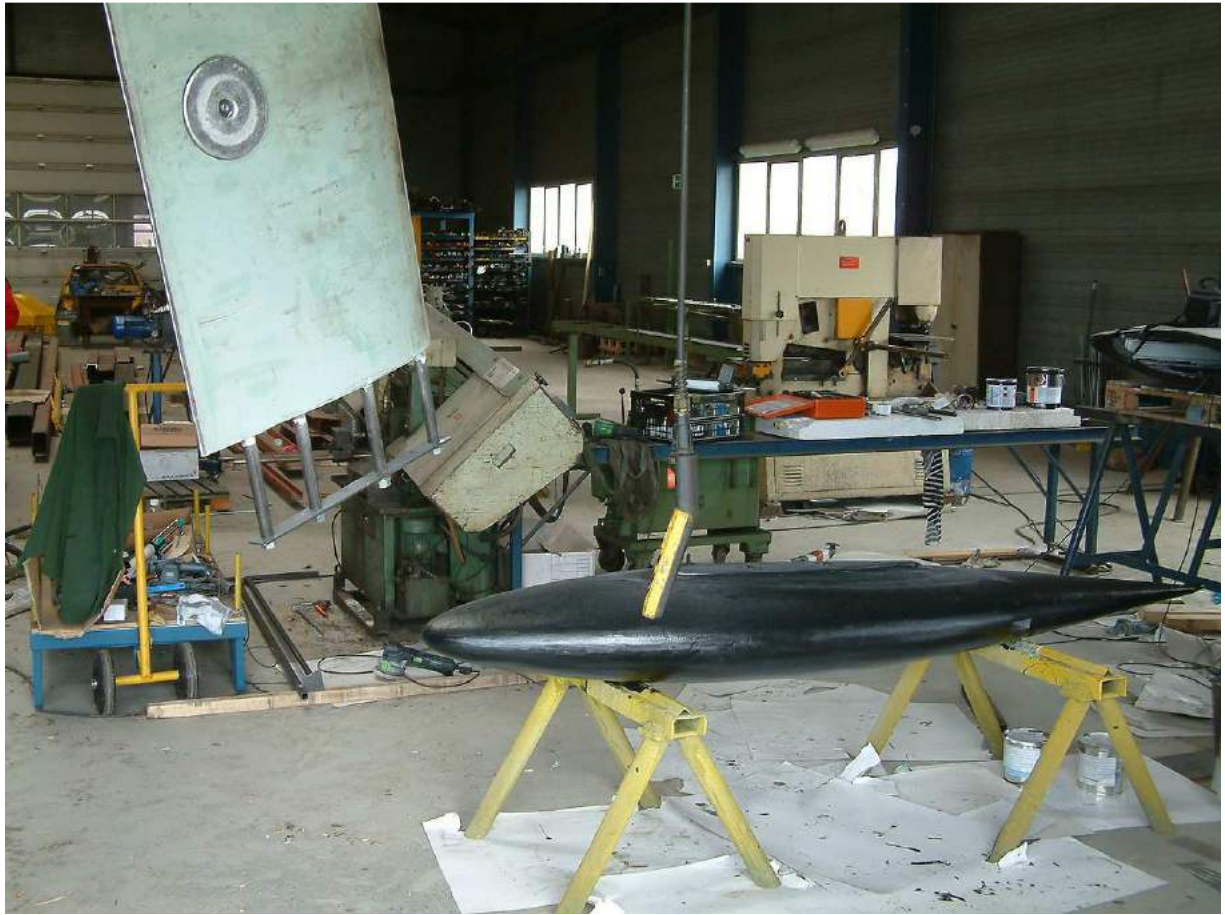
***Lead bulb with steel internal frame - foam mold of bulb***
