Inspection of Bottom Plating Damage & Repair Proposal

Report date: 23rd April 2020
 Report no.: 172-01-Rev 00
 Survey date: First Visit 26th November 2019
 Final Visit 4th March 2020
 Location of Survey: Estepona Marina Hardstanding, Spain
 In water/Ashore/At Sea: Ashore, supported on hardstanding
 Client: John Tiernan, Ireland

Vessel Name: ZAMBA
 OFF Number: 390309
 Port of Registry: Jersey
 Date of build: 1986

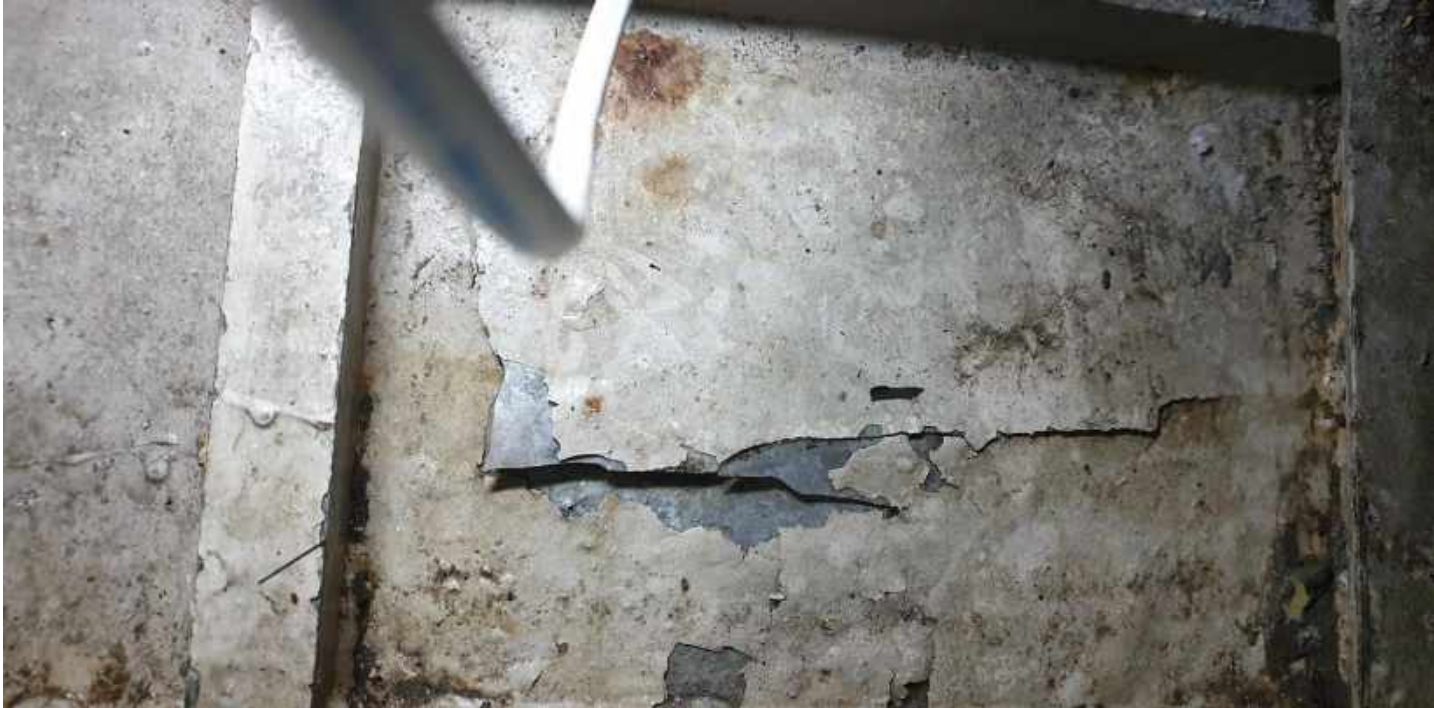
Picture of crack in Hull from inside prior to Temp Repair taken in Sept 2019.. supplied by Client

Thickness of hull plating was measured in areas of damage using Cygnus UTM giving results of 4.8 to 5.2 mm using an Aluminium Conversion factor 1.068 from Steel to Aluminium. This would be the expected design thickness. Given this thickness it is considered that the damage was caused by an external force as opposed to wear.

The crack that was the cause of the initial leak was Temporary repaired with a patch ; The temporary repair was by way of epoxy patch covered with an aluminium plate braced with timber struts . Please find above photograph of the impact damage prior to the temporary repair having been carried out.

The damage appears to have been caused by a local vertical impact at mid panel between the stiffeners identified in September 2019 . The outside fairing compound (appears to be polyester type resin) was damaged locally only at said crack.

The type of damage to cause this type of crack is considered to be of a type of punch through the bottom plating possibly from bottoming out due to low tide or badly positioned support props or possibly hit by another craft s under hull in the tuning circle in the marina adjacent to the moored Boat which is on the same side as the impact damage.

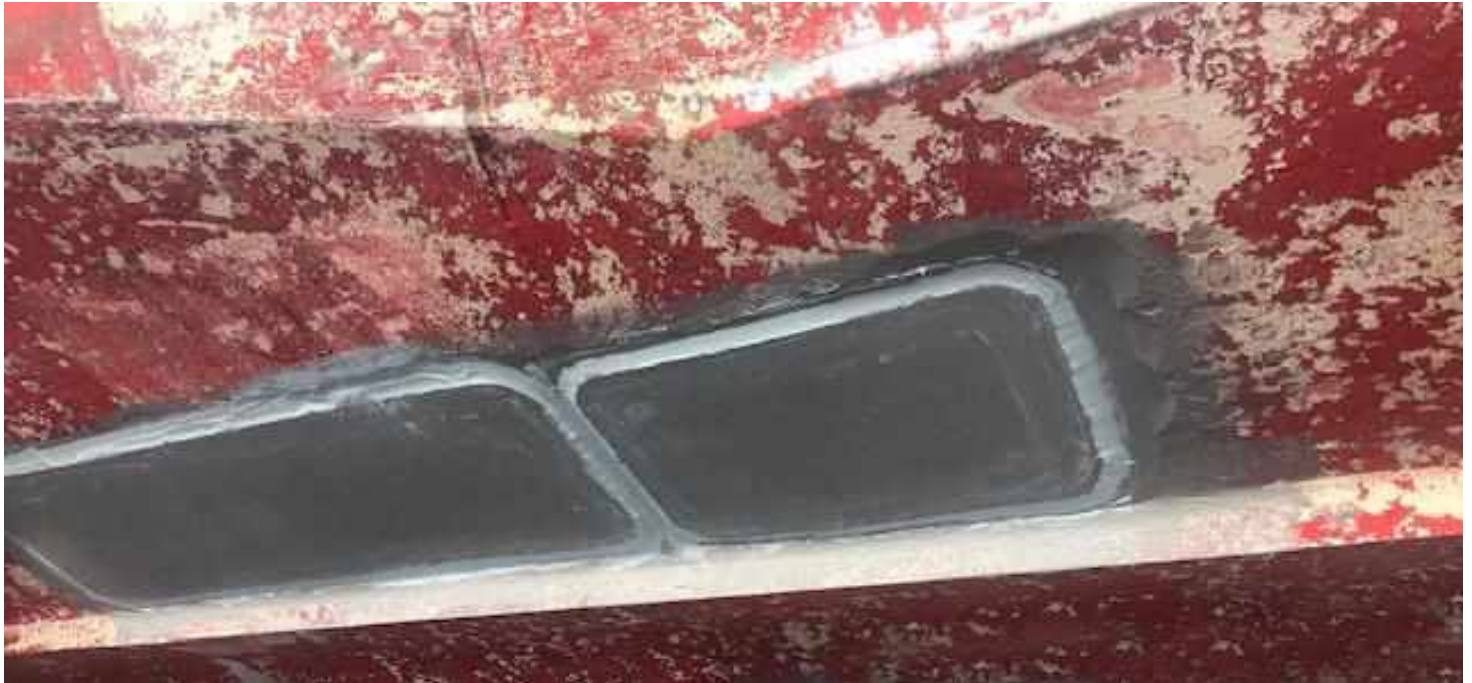
All existing patches had been removed and fairing compound removed.

A check of all plating externally and internal plating and structure where accessible was made. The hull plating and structure is well fabricated with little or no apparent degradation of the aluminium alloy for the age of vessel.

After the inspection of the bottom after removal of the fairing as required, a repair procedure to clean and grind flush damage and weld 6mm marine grade (5086 H111) doubler plates with radiused corners in way of the damage was agreed to ensure a suitable semi-permanent repair.

In addition, to ensure the longevity of the repair, the internal surface in way of the damaged shell plating should be cleaned and after the external plates are welded in place a suitable marine grade epoxy resin shall be poured into the bays between longitudinal and transverse stiffening to ensure no ingress of water into the area between external plate and existing shell plate would be possible.

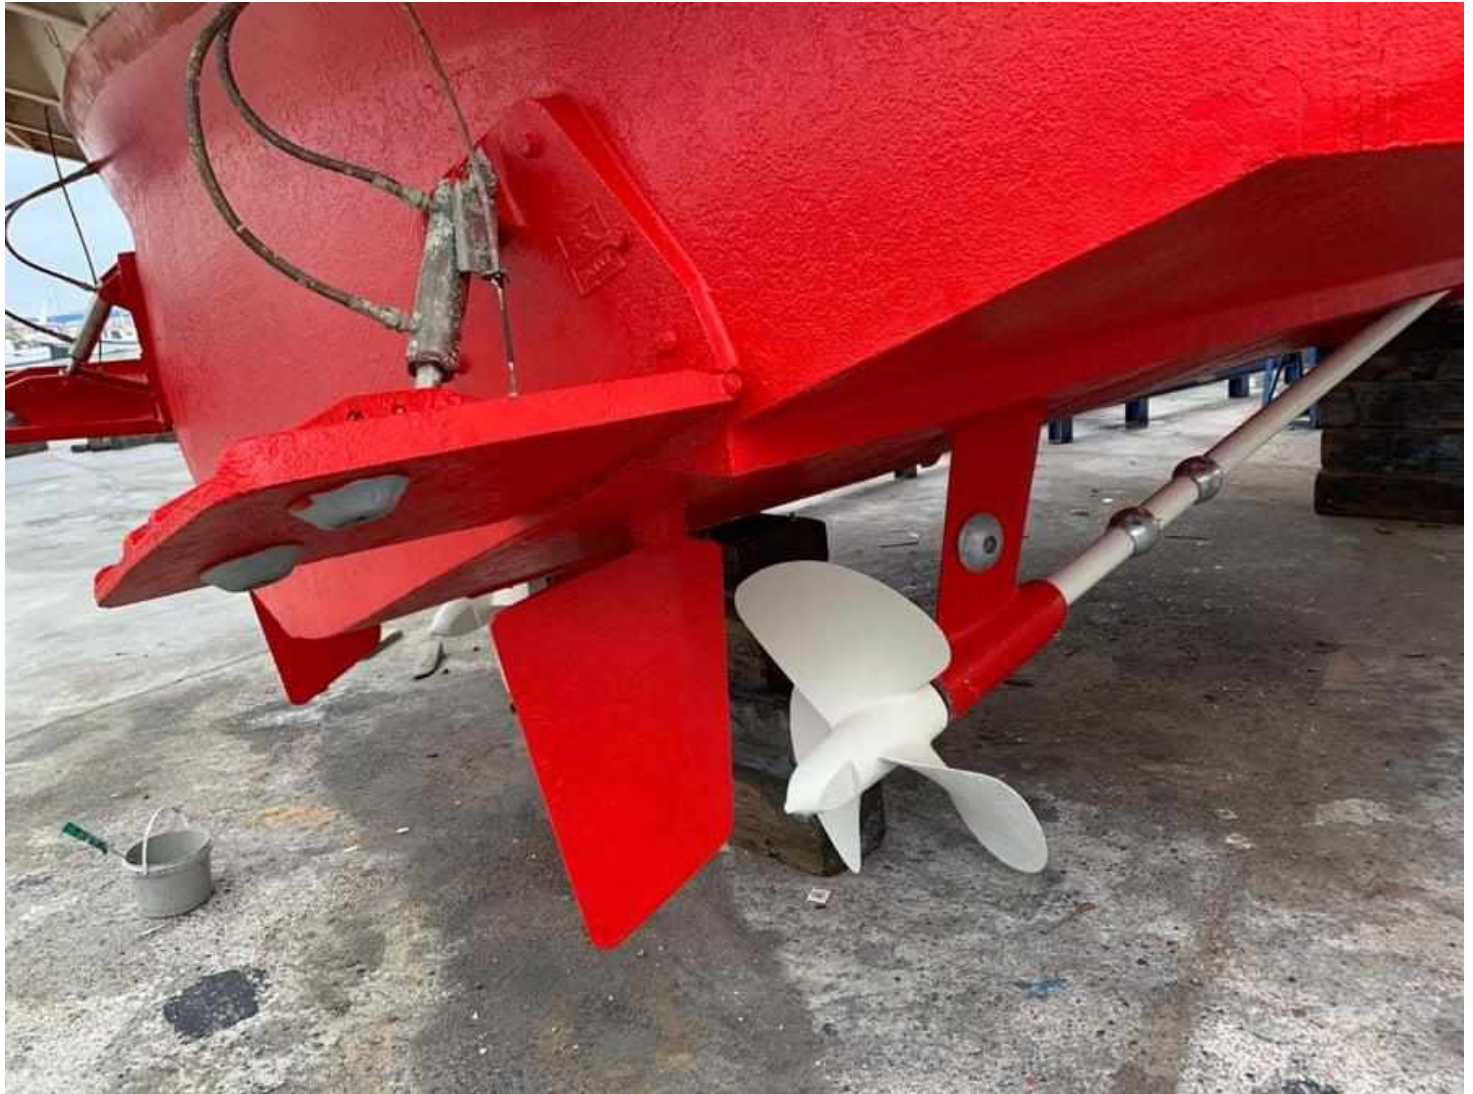
Picture of Hull during Antifouling .. supplied by Client

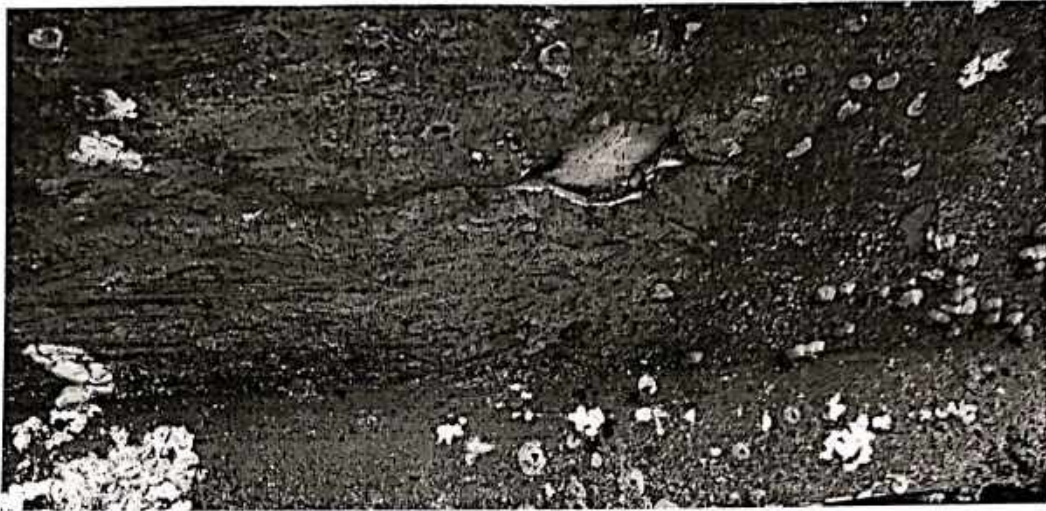
On inspecting the entire hull I found same to be in good condition with the normal wear and tear that would be expected of a craft of its age. I gave particular attention to the crack on the site of the boat which appears to be as a result of a punching force with two similar cracks (which I understand were not leaking) adjacent to same – see **photo 1**.

My proposed repairs comprised the welding of plates as opposed to the riveting of same in the location of the leak from the impact force.

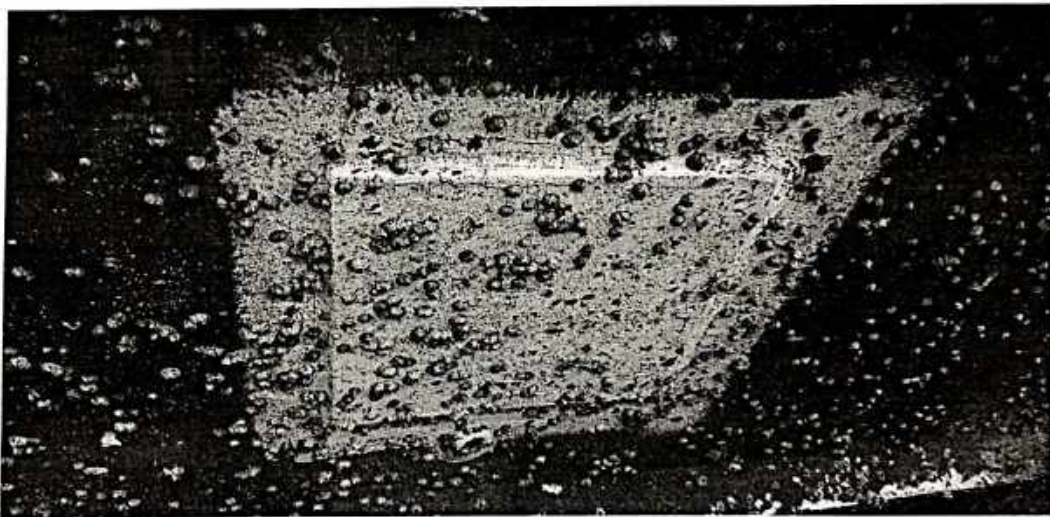
I also noticed some patching that appeared to have been carried out a number of years ago and I note it was highlighted in the previous boat survey carried out in 2015.

These plates were in a single area and had been riveted to the boat – see *photo 2*.

I also proposed the removal of the existing plates (although they were not leaking) in favour of welded plates as same were a superior job and would look better.
