Inspection of Bottom Plating Damage & Repair Proposal

Report date: 23rd April 2020
 Report no.: 172-01-Rev 00
 Survey date: First Visit 26th November 2019
 Final Visit 4th March 2020
 Location of Survey: Estepona Marina Hardstanding, Spain
 In water/Ashore/At Sea: Ashore, supported on hardstanding
 Client: John Tiernan, Ireland

Vessel Name: ZAMBA
 OFF Number: 390309
 Port of Registry: Jersey
 Date of build: 1986

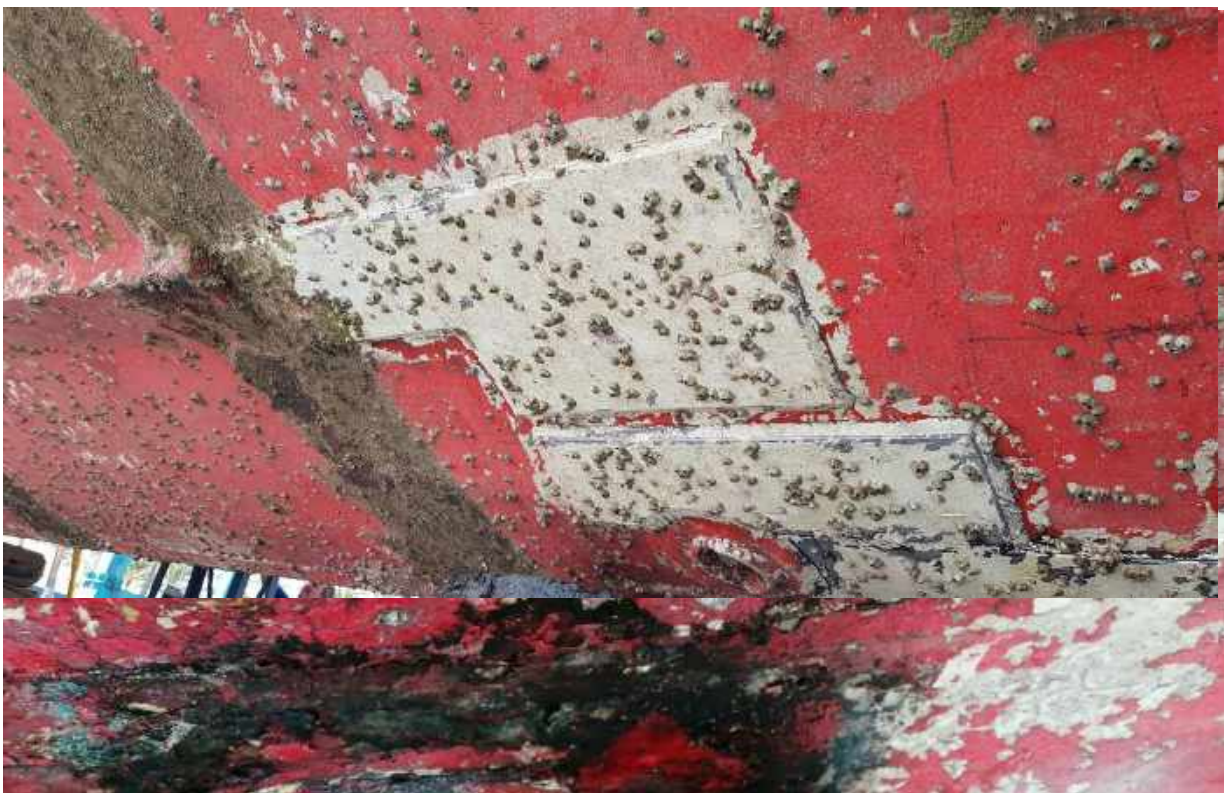
The damage appears to have been caused by a local vertical impact at mid panel between the stiffeners identified in September 2019 . The outside fairing compound (appears to be polyester type resin) was damaged locally only at said crack.

The type of damage to cause this type of crack is considered to be of a type of punch through the bottom plating possibly from bottoming out due to low tide or badly positioned support props or possibly hit by another craft s under hull in the tuning circle in the marina adjacent to the moored Boat which is on the same side as the impact damage.

The location of the crack on the vessel indicates that the plate crack was caused by local punch type impact damage so we consider that this has been caused by local grounding/ or similar to bad propping of the vessel ashore. This type of damage appears to have occurred with the vessel stationary, otherwise we would expect to see damage in way of the longitudinal and transverse supports or a more continuous damage longitudinally (raking damage), this is not the case. In addition, if the vessel structure was not robust for the vessel operation it would be expected to find the damage to be of a more uniform pattern on the shell.

At the conclusion of the first visit, it was agreed to carry out a welded type repair and at the same time (while not leaking) check the other “patched” areas that all rivetted patches are removed and any areas where fairing compound is damaged the filler will be removed to allow inspection as the boat was in Dry Dock

After the inspection of the bottom after removal of the fairing as required, a repair procedure to clean and grind flush damage and weld 6mm marine grade (5086 H111) doubler plates with radiused corners in way of the damage was agreed to ensure a suitable semi-permanent repair.

In addition, to ensure the longevity of the repair, the internal surface in way of the damaged shell plating should be cleaned and after the external plates are welded in place a suitable marine grade epoxy resin shall be poured into the bays between longitudinal and transverse stiffening to ensure no ingress of water into the area between external plate and existing shell plate would be possible.
